# **INDOOR AIR QUALITY ASSESSMENT**

**Granville Village School  
409 Main Street  
Southwick/Tolland Regional School District  
Granville, Massachusetts**

Prepared by:  
Massachusetts Department of Public Health  
Bureau of Environmental Health Assessment  
July, 2000

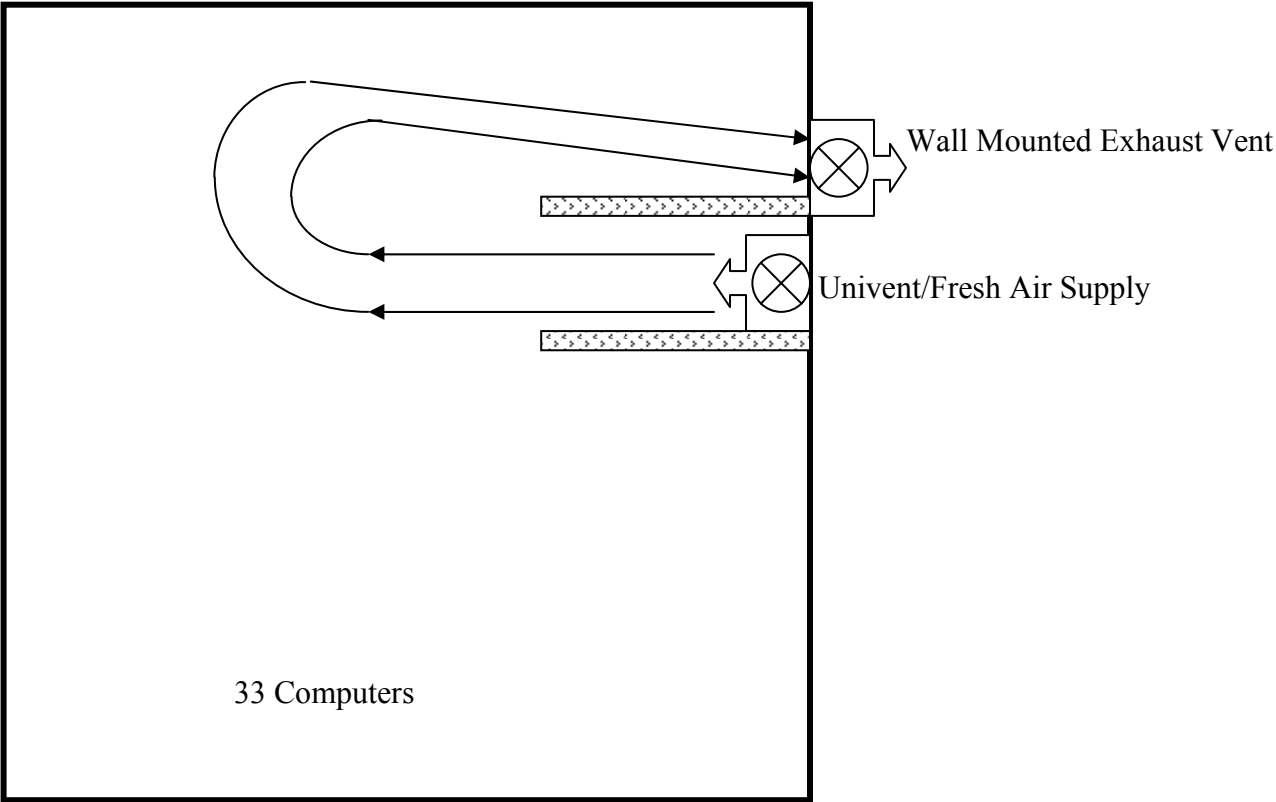
Figure 2

Of note is the configuration of the media center/library ventilation system (see Figure 2). It appears the sole source of fresh air for this room is a single univent that was blocked by a poster board (see Picture 1). The sole exhaust vent for this area is a wall-mounted grille located above the univent. The placement of the univent and exhaust vent appears to supply fresh air to only half of the room. The univent is straddled by bookshelves, which limit the draw of air to the south half of the room. The exhaust vent in close proximity to the univent tends to draw air from the south section of the room. This configuration creates a dead spot of little or no airflow in the area around the north section of the room. This area is used as a computer lab and contains 30 computers (see Figure 2). With a lack of airflow, heat from computers in this area can build up.

Airflow in the Media Center Library

5. Consider reconfiguring the media center/library to remove bookshelves that straddle the univent. Examine the feasibility of moving the computer stations closer to the exhaust vent airstream.

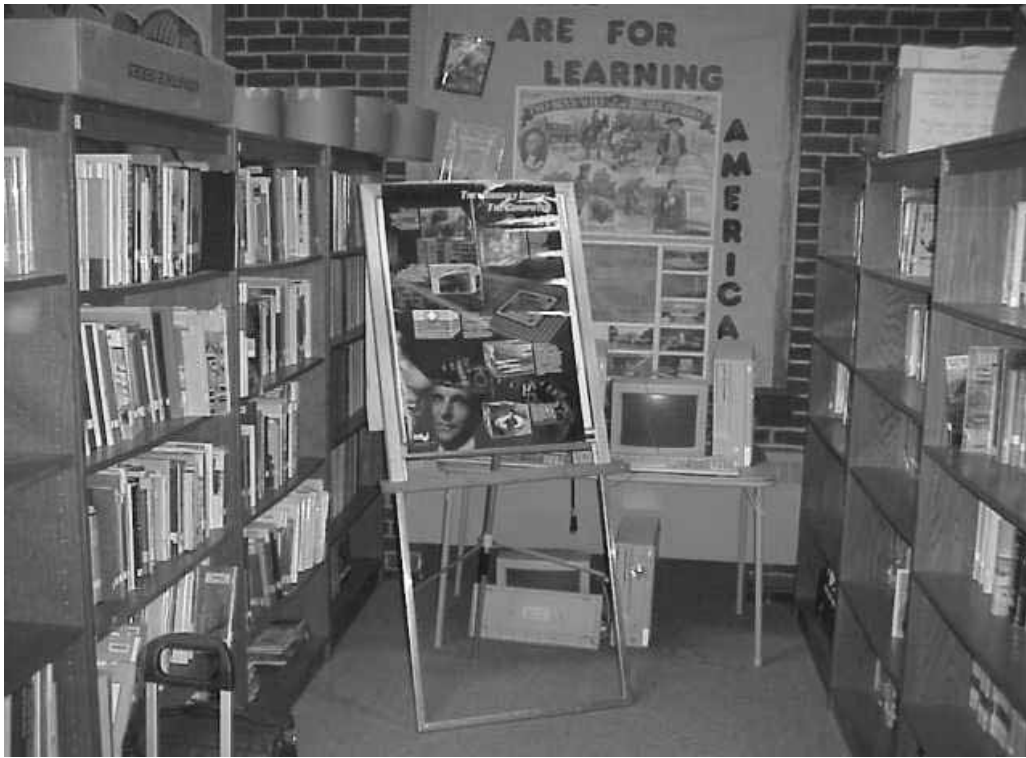
**Picture 1**

**Univent Blocked With Poster Board**

2. Remove all obstructions from univents and mechanical exhaust vents to facilitate airflow. Ensure all exhaust ventilation flues are open and operational. Operate exhaust ventilation during occupancy. Examine exhaust motors for function. Increase exhaust if necessary.

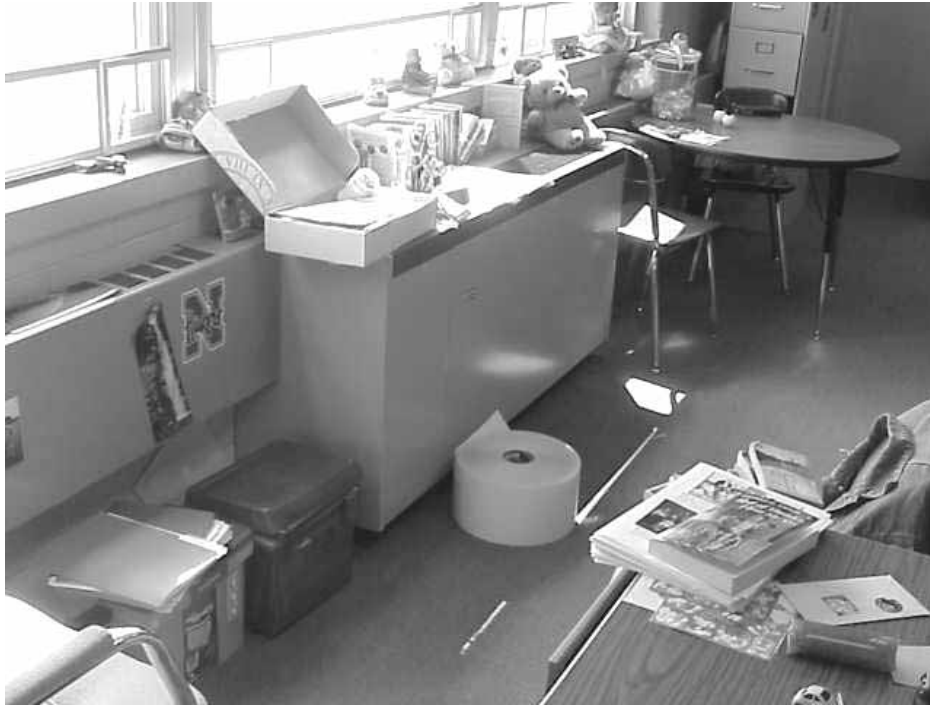
**Picture 2**

Fresh air in classrooms is supplied by a unit ventilator (univent) system (see [Figure 1](#)). Univents draw air from outdoors through a fresh air intake located on the exterior walls of the building and return air through an air intake located at the base of each unit. Fresh air and return air are mixed, filtered, heated and provided to classrooms through a fresh air diffuser located in the top of the unit. In order for univents to provide fresh air as designed, they must be unblocked and remain free of obstructions. Importantly, these units must be activated and allowed to operate. Univents were functioning in the majority of classrooms examined, however several univents were deactivated. Obstructions to airflow such as paper, boxes, shelves and other obstructions (see Pictures 1-2) were seen in a number of classrooms.

**Air Diffuser Blocked With Paper, Return Vent Blocked with Paper Roll**

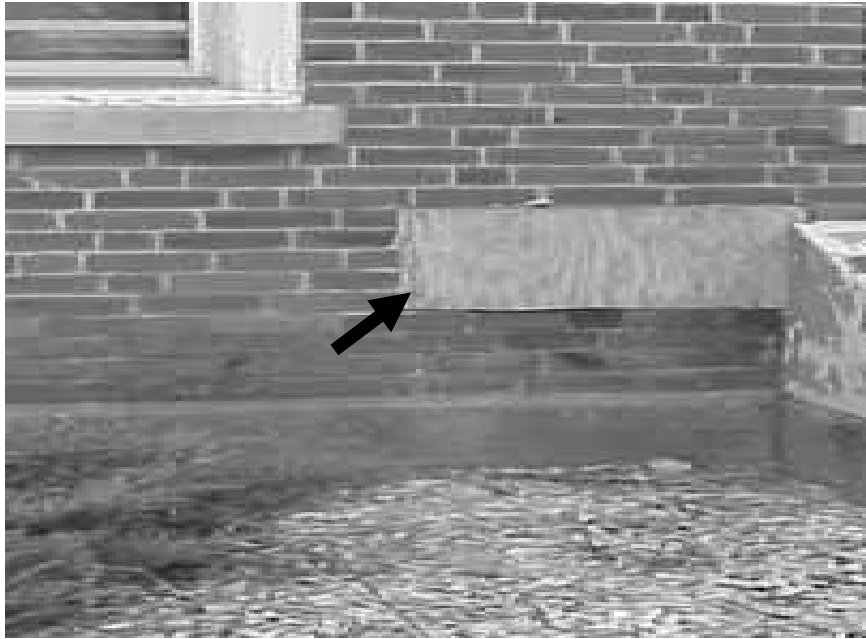
**Picture 3**

The fresh air intake for the kindergarten classroom was sealed with plywood (see Picture 3). As reported by school officials, the fresh air intake was sealed because the univent's heating coil was prone to freezing in cold weather. Northwest winter winds can force cold air into this univent interior, freezing the coil. Therefore, this univent does not have a functioning fresh air intake.

**Kindergarten Univent Fresh Air Vent Blocked With Plywood**

3. Examine the feasibility of installing a hood/barrier to shield the kindergarten univent fresh air intake from northwest winds.
4. Repair the exhaust vent motor for the 1964 wing. Remove the bird's nest.

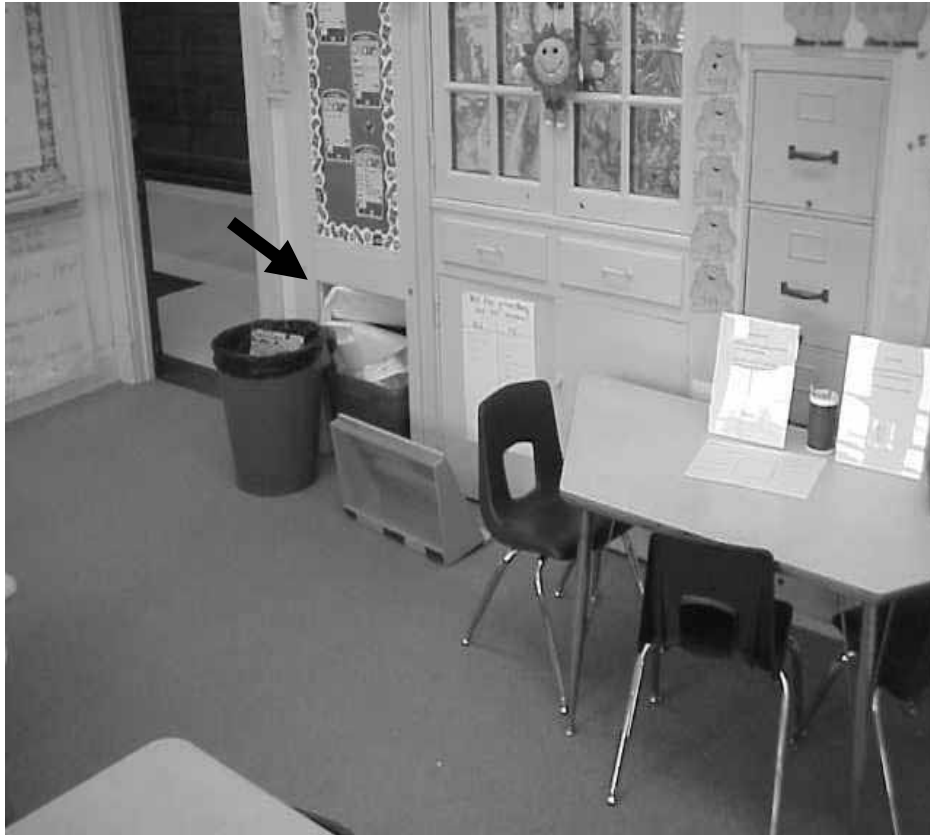
**Picture 4**

No functioning mechanical exhaust ventilation exists in the 1934 building. Exhaust ventilation in the 1934 building consists of a series of gravity feed wall vents (see Picture 4). These vents were sealed at the classroom level with plywood (see Picture 5). No airflow was detected from these vents. Each classroom is constructed around a ventilation airshaft that terminates in the roof in cupola-like structures (see Picture 6). Above each vent of a classroom is a radiator-like heating element. The heating element heats air, which rises and exits the building through the rooftop vents. As the heated air rises up the vent shaft, classroom air is drawn into the vent.

**Original Exhaust Vent In 1934 Building**

1. Install a gutter and drainage system.
2. Examine the feasibility of providing mechanical exhaust ventilation in the 1934 building. A former make-up air vent (see Picture 17) for the furnace exists in the northwest wall of the school. Consider the feasibility of installing below floor ducts in the 1934 building basement and using the old furnace make up air vent as the terminus for a mechanical exhaust vent. If this is done, ensure that the system design does not deliver exhaust air to the kindergarten fresh air intake vent.
3. Examine the feasibility of providing a fresh air supply for the art room.
4. Consider the feasibility of increasing fresh air delivery to the media center/library with an upgraded univent system, installation of ceiling fans or removal/restoration of the original ceiling system to increase the volume of the room.

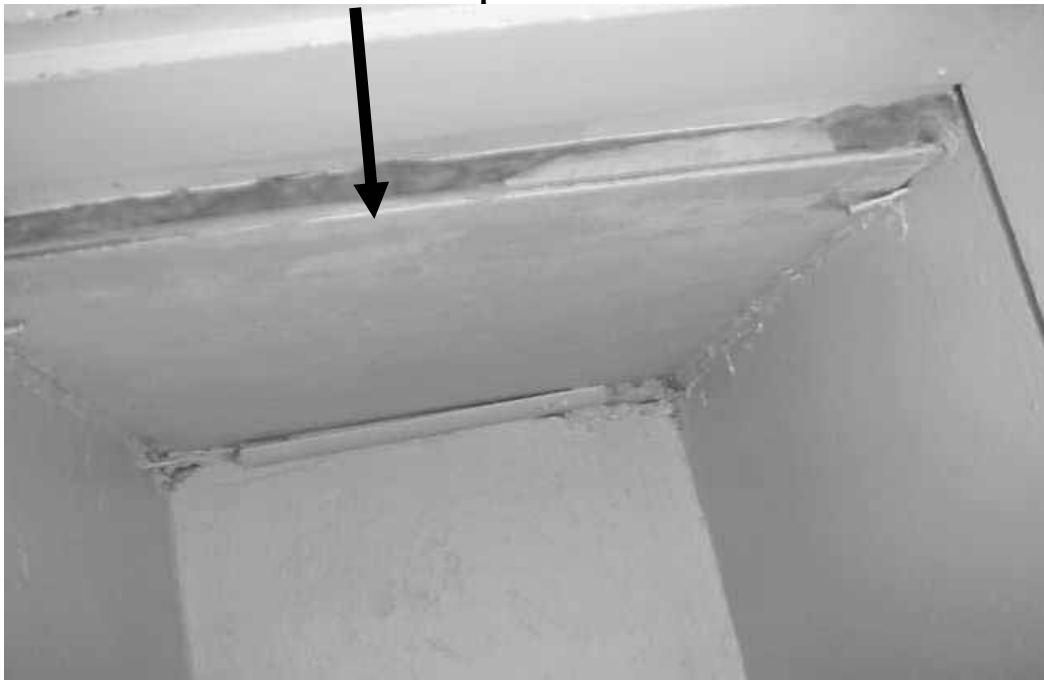
**Picture 5**

**Interior Of 1934 Building Exhaust Vent Sealed With Plywood**

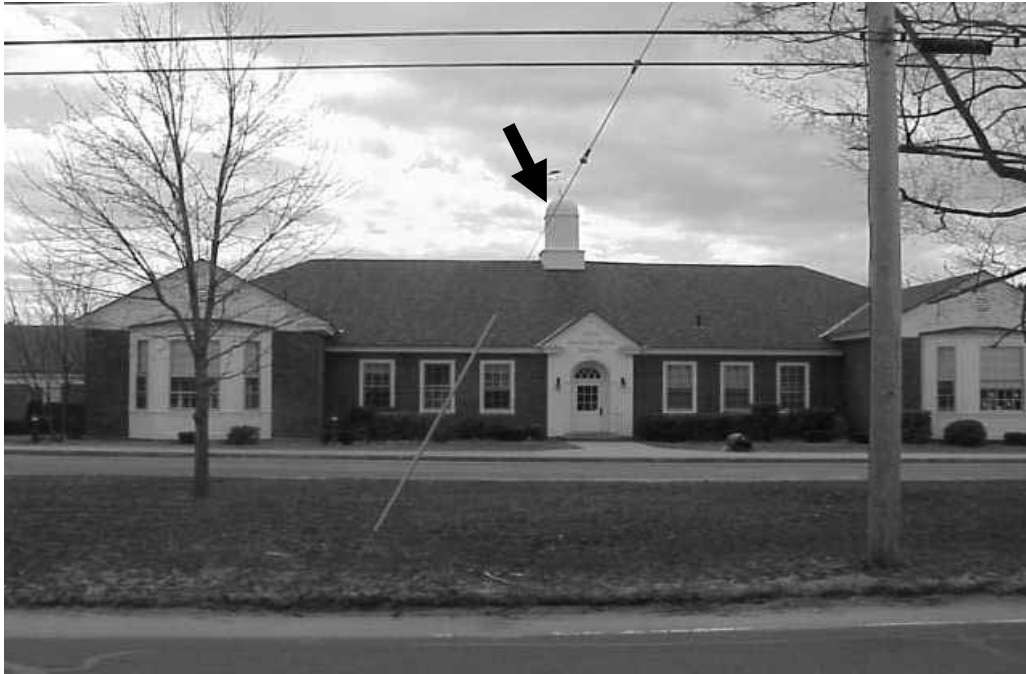
**Picture 6**

**Exhaust Vent Cupola of 1934 Building**

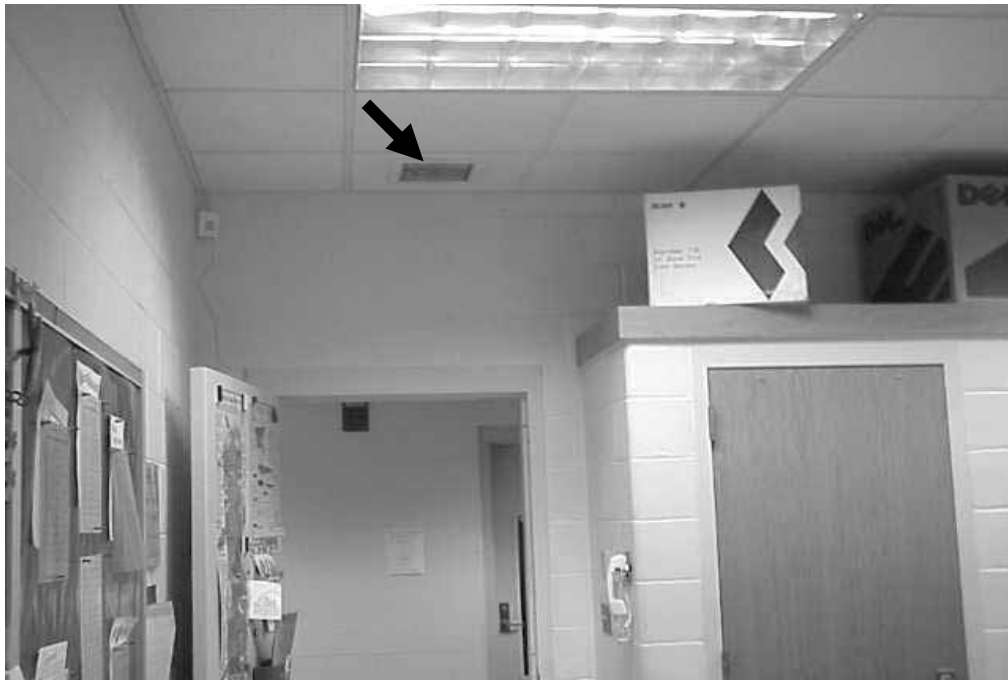
**Picture 7**

Exhaust ventilation in the remainder of classrooms is provided by wall or ceiling mounted exhaust vents connected to mechanical fans by ductwork. The location of exhaust vents can also limit exhaust efficiency when the classroom hallway door is open (see Picture 7). When a classroom door is open, exhaust vents will tend to draw air from both the hallway and the classroom. The open hallway door reduces the effectiveness of

the exhaust vent to remove common environmental pollutants from classrooms. Without removal by the exhaust ventilation, normally occurring indoor pollutants can build up in classrooms.

**Exhaust Vent over Doorway**

7. Instruct room occupants to keep hallway doors closed to enhance exhaust ventilation in classrooms with ceiling mounted exhaust vents.
8. For buildings in New England, periods of low relative humidity during the winter are often unavoidable. Therefore, implementation of scrupulous cleaning practices, to minimize common indoor air contaminants whose irritant effects can be enhanced when the relative humidity is low, should be implemented. Among these methods can be the use of vacuum cleaning equipment outfitted with a high efficiency particulate arrestance filter (HEPA). Drinking water during the day can

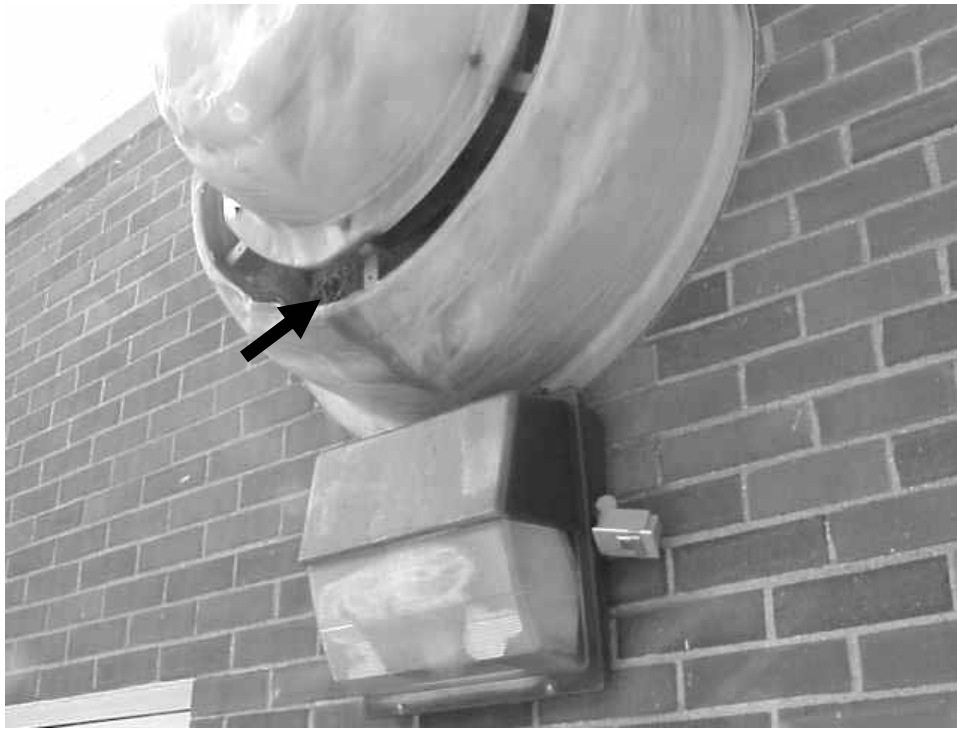
**Picture 8**

The exhaust vents in the 1964 wing appeared to be deactivated. The exhaust vent fan for this wing was found deactivated and had a bird's nest inside the casing (see Picture 8). Exhaust ventilation in the remainder of classrooms was operating.

**Bird's Nest Noted in Exhaust Vent Motor for 1964 Wing**

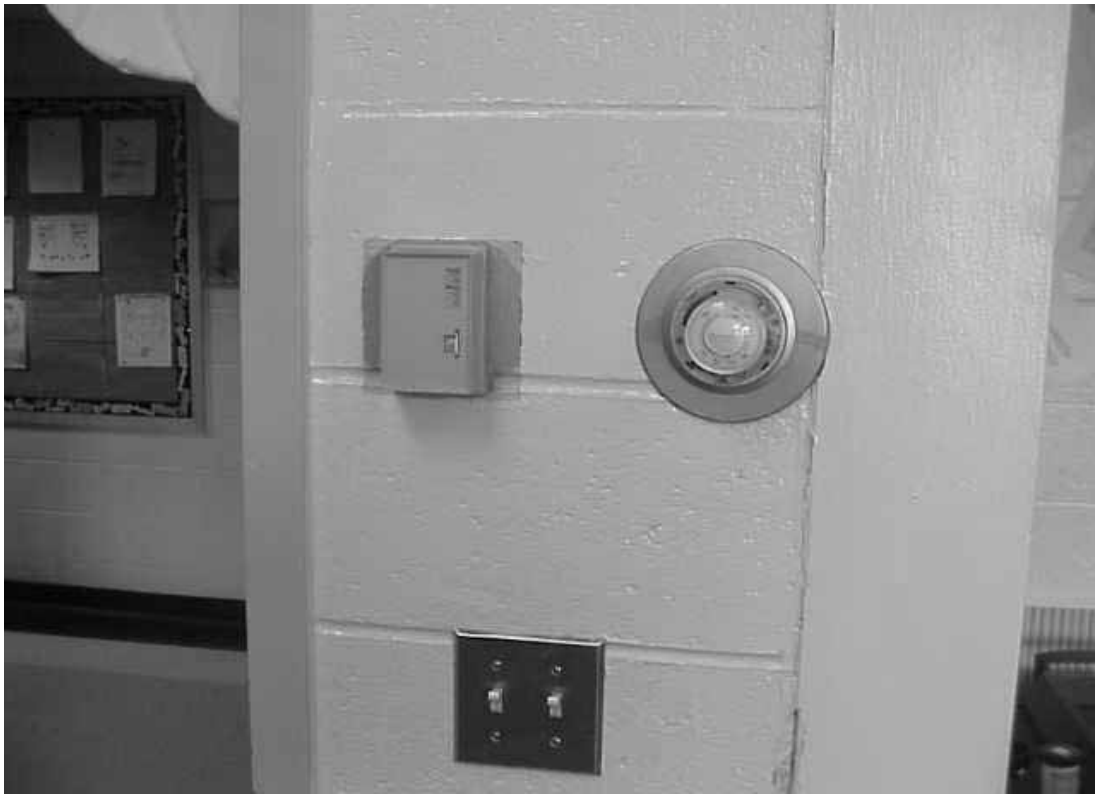
**Picture 9**

Temperature readings ranged from 71° F to 75° F which were within the recommended range. The BEHA recommends that indoor air temperatures be maintained in a range of 70° F to 78° F in order to provide for the comfort of building occupants. In many cases concerning indoor air quality, fluctuations of temperature in occupied spaces are typically experienced, even in a building with an adequate fresh air supply. Of note was the presence of dual thermostats in some classrooms (see Picture 9). It could not be determined which thermostat controlled the operation of the univent heat. It should be determined which thermostat controls the operation of the univent. The other thermostat should be removed.

**Two Thermostats in the Same Room**

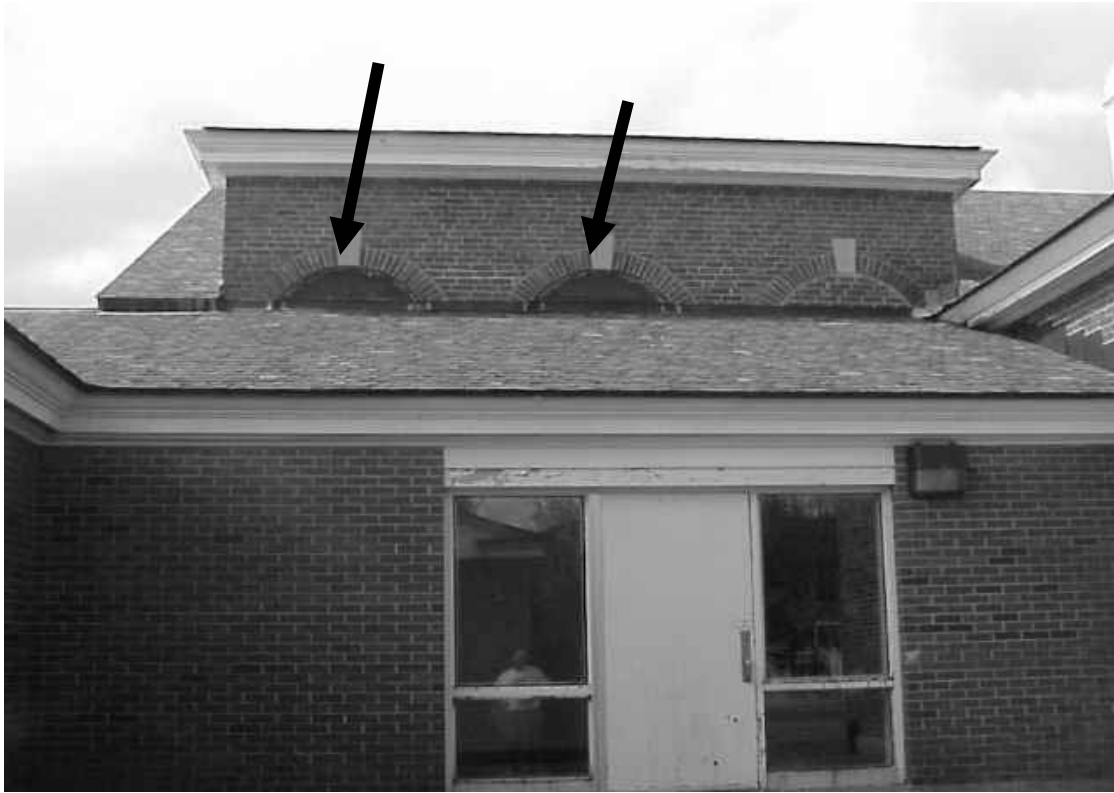
**Picture 10**

The media center had a number of water-damaged ceiling tiles that can indicate leaks from either the roof or plumbing system. The media center/library was converted from a gymnasium during the 1989 renovations. Originally, this room had an open ceiling with three windows on the eastern wall. These windows were sealed and a suspended ceiling was installed above the window frames. The exterior of each window frame was also sealed, one with brick, the other with plywood (see Picture 10). Ceiling tiles around the edges of the plywood sealed window frames were water damaged. This condition indicates that rain/moisture is penetrating through the seams of the plywood plugs. In addition, fiberglass insulation was installed on top of the ceiling tiles. Fiberglass insulation and ceiling tiles can serve as growth media for mold, especially if wetted repeatedly. These materials should be replaced after a water leak is discovered and repaired.

**Windows of Former Gymnasium, Note Plywood Sealing Window Frame**

9. Examine the seal of the media center/library window plugs for water tightness. Once water-tightness is reestablished, replace any remaining water-stained ceiling tiles. Remove water damaged fiberglass insulation. Examine the area above and behind these tiles for mold growth. Disinfect areas of water leaks with an appropriate antimicrobial.

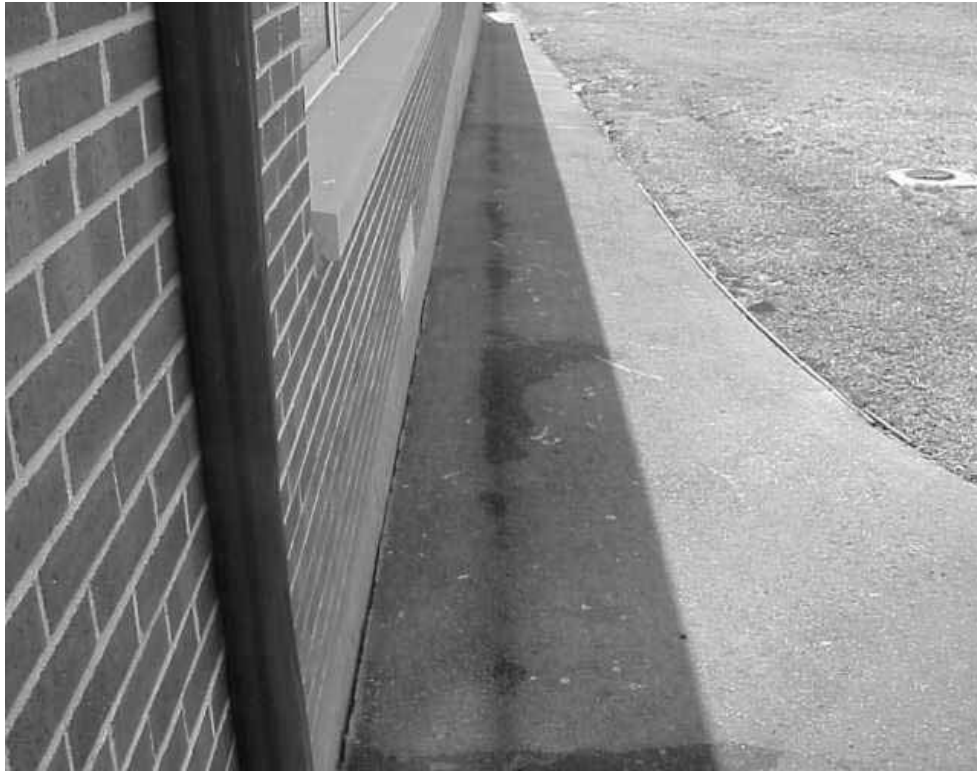
**Picture 11**

Of note is the lack of roof gutters and downspouts on the sloped roof of the building complex. While water damage from rainwater around the building appears to be minimal, the exterior brick of the main building is coated with mud (see Picture 11), which indicates significant water exposure. The source appears to be rainwater runoff. Areas around the exterior of the 1989 wing have a layer of asphalt that extends from the base of the building for approximately two feet. Cracks between this asphalt layer and the exterior wall can result in water penetrating into the building over time.

**Exterior Brick and Asphalt Discoloration Indicating Water Contact**

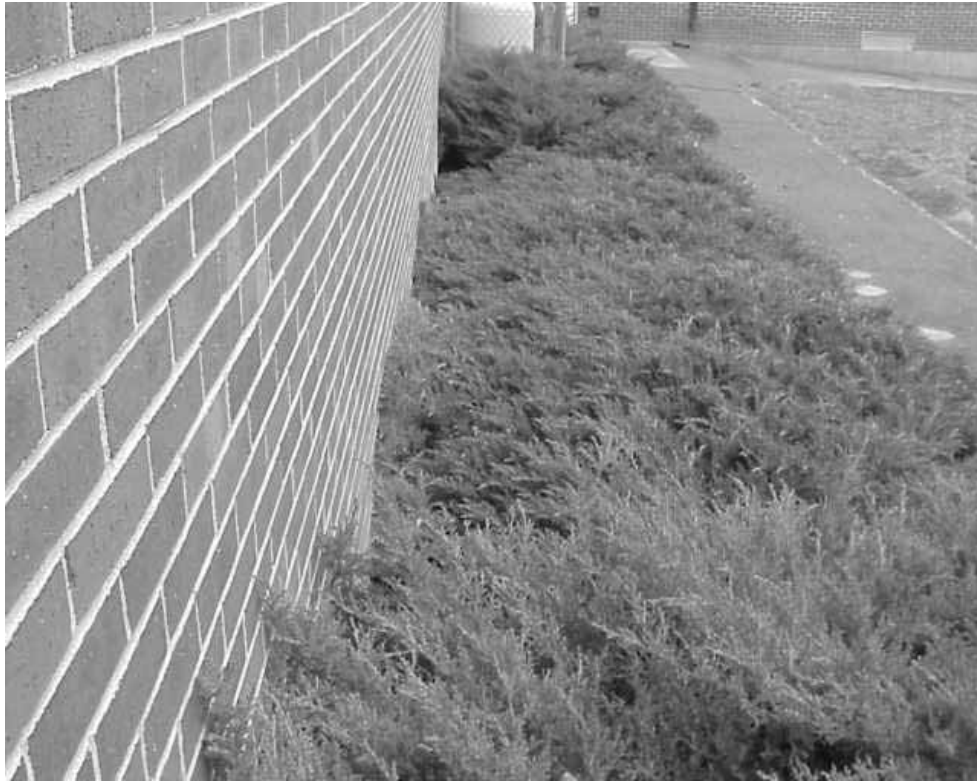
**Picture 12**

Shrubbery in direct contact with the exterior wall brick was noted in several areas around the building (see Picture 12). Shrubbery can serve as a possible source of water impingement on the exterior curtain wall due to the location of plants and tree branches

growing directly against the building. Plants retain water and in some cases can work their way into mortar and brickwork causing cracks and fissures, which may subsequently lead to water penetration and possible mold growth.

**Shrubbery Impinging On Exterior Wall of Gymnasium**

10. Reduce/trim or remove plants that are growing against the exterior brick curtain wall.
11. Move plants away from univents in classrooms. Ensure plants have drip pans. Examine drip pans periodically for mold growth and disinfect with an appropriate antimicrobial where necessary.

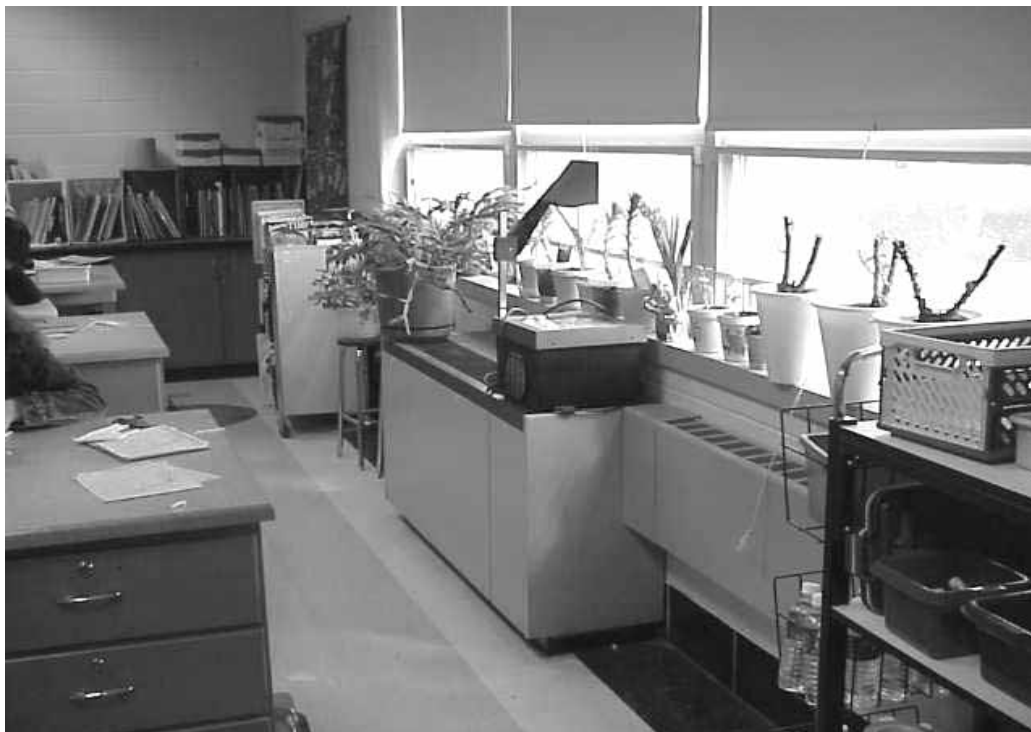
**Picture 13**

Several classrooms also had a number of plants located in/or around univent returns or air diffusers (see Pictures 13). Plant soil and drip pans can serve as a source of mold growth. A number of these plants did not have drip pans. The lack of drip pans can lead to water pooling and mold growth on windowsills when used indoors. Wooden sills can be potentially colonized by mold growth and serve as a source of mold odor. Plants should also be located away from univents to prevent the aerosolization of dirt, pollen or mold.

**Plants Over Univent**

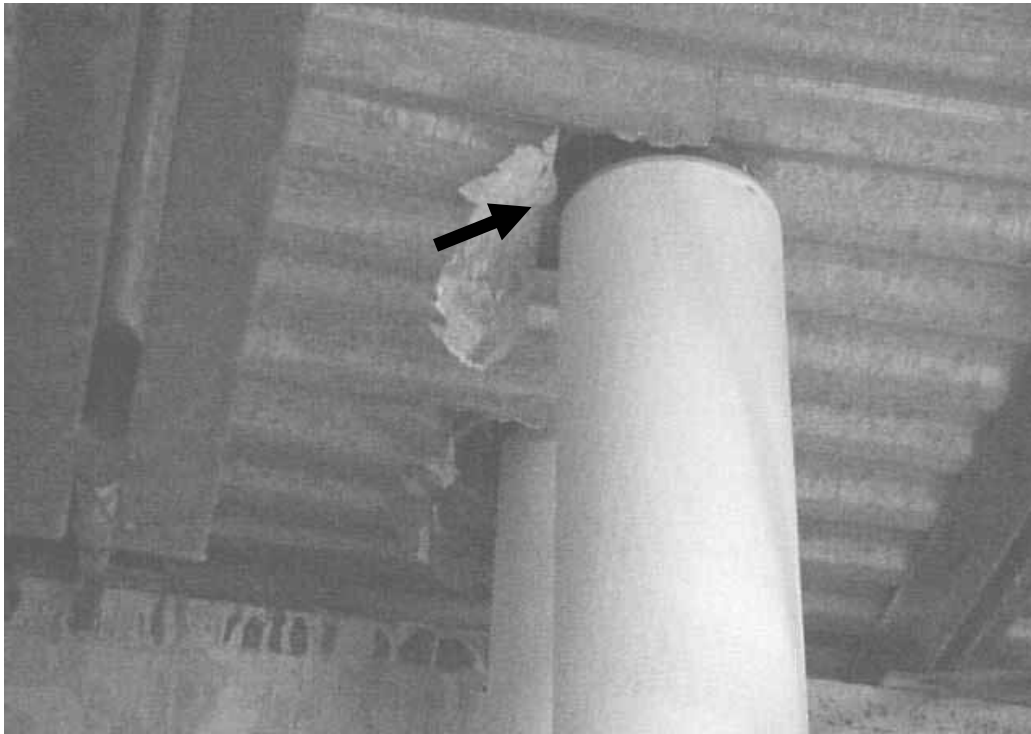
**Picture 14**

Open holes around utility pipes were noted in the floor decking of the 1989 wing (see Picture 14). Open pipes and utility holes can provide a means of egress for odors, fumes, dusts and vapors from the storage space into classrooms.

**Hole In Floor Decking Of 1989 Wing**

16. Seal open holes around utility pipes to prevent odor and dust movement.

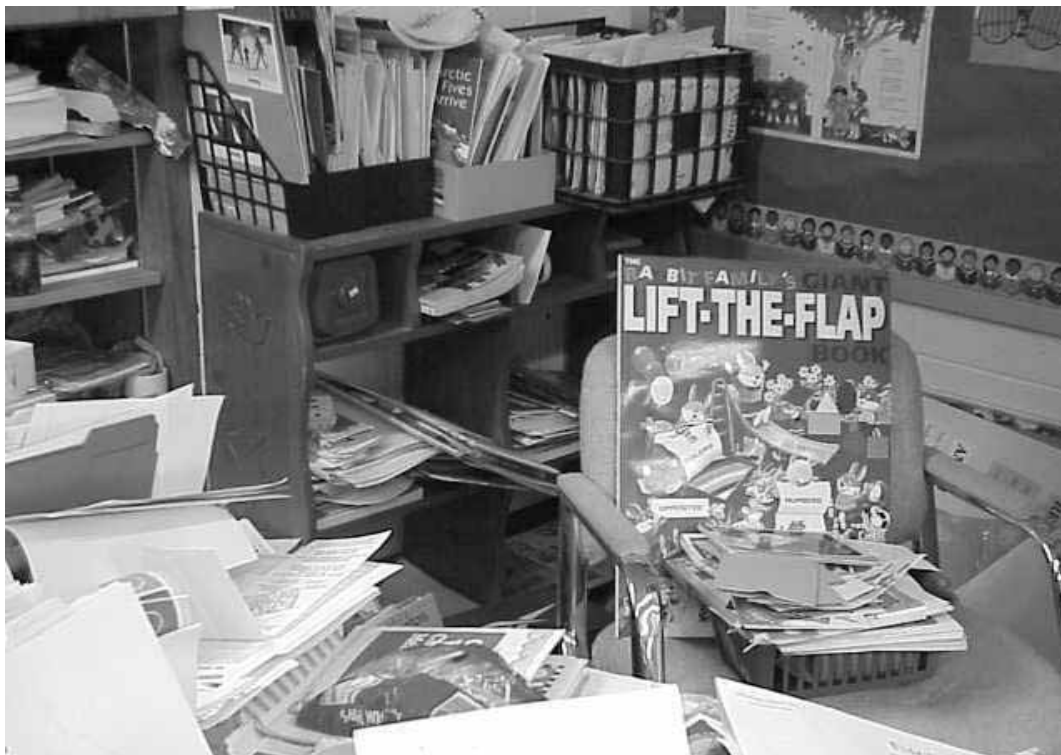
**Picture 15**

Also of note was the amount of materials stored inside classrooms (see Pictures 15 and 16). In classrooms throughout the school, items were seen piled on windowsills, tabletops, counters, bookcases and desks. The large amounts of items stored in classrooms provide a surface for dusts to accumulate. These items, (e.g. papers, folders, boxes, etc.) make it difficult for custodial staff to clean around these areas. Accumulated chalk dust was noted in several classrooms. Chalk dust is a fine particulate, which can become easily aerosolized. Household dust and chalk dust can be irritating to the eyes, nose and respiratory tract. These items should be relocated and/or cleaned periodically to avoid excessive dust build up.

**Stored Classroom Material**

13. Relocate or consider reducing the amount of materials stored in classrooms to allow for more thorough cleaning of classrooms. Clean items regularly with a wet cloth or sponge to prevent excessive dust build-up.

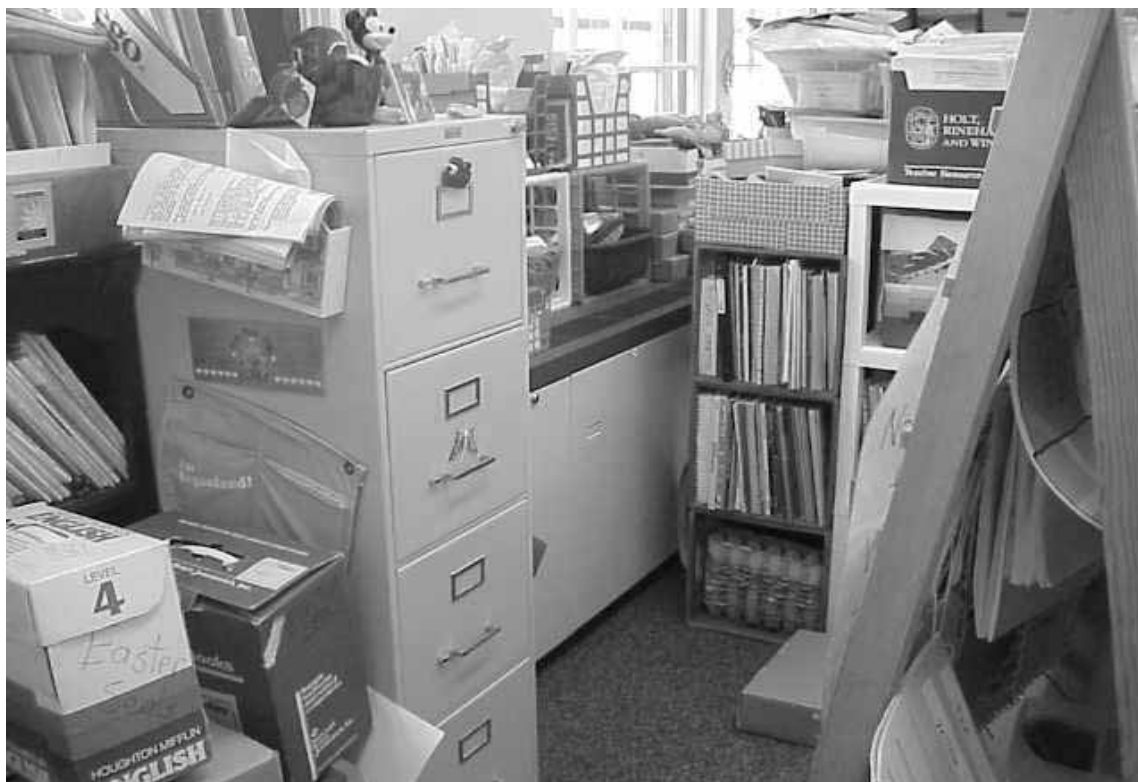
**Picture 16**

**Stored Materials Blocking Univents**

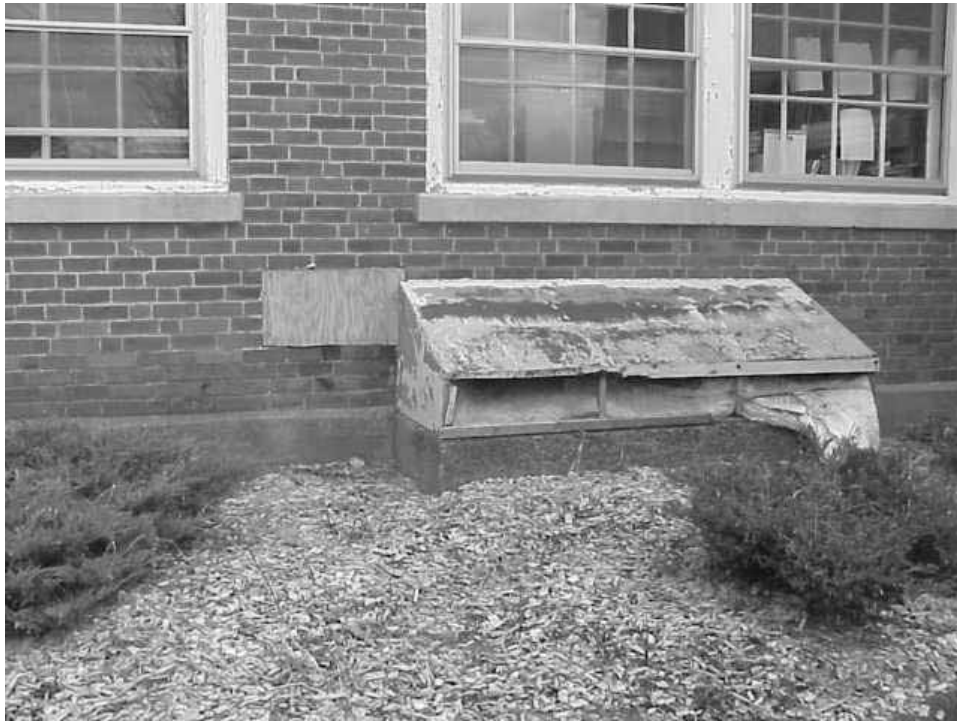
**Picture 17**

**Former Make-Up Air Vent for Boiler**
